Accelerated Aging and Life Time Prediction for Solar Concentrators

CSP Today 2015, Sevilla

J. Wette, F. Sutter (DLR)
A. Fernandez (CIEMAT)

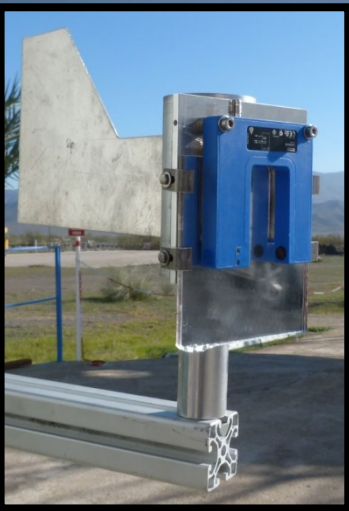
Light barrier
attached to
mirror in 5
different
heights
>40 μ m

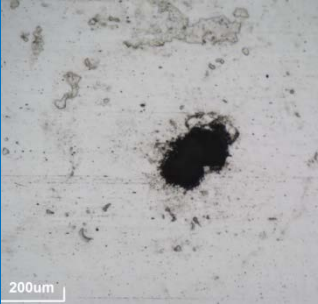
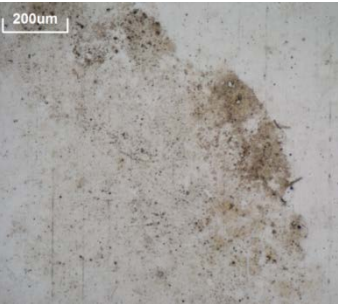
Top coating erosion	PVD-layer corrosion	Pitting corrosion	Micropitting PVD-layer	Deposits
Outdoor test

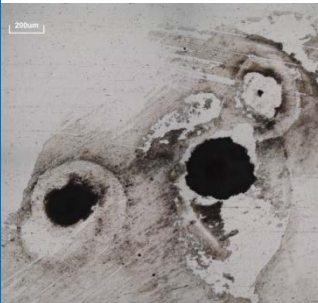
Accelerated aging tests

DIN52348 (Sand trickling test) Silica 300-650 µm	ISO9227 (NSS), 1000h	ISO9227 CASS, 100h	ISO11507 (UV/humidity), 1000h	ISO11507 + soiled surface with Tabernas dust, 1000h
